Subject: Docket No. 50-482: LER 2009-002-00, Loss of Offsite Power due to Lightning

1. FACILITY NAME
WOLF CREEK GENERATING STATION2. DOCKET NUMBER
05000 4823. PAGE
1 OF 6

4. TITLE Loss of Offsite power due to Lightning

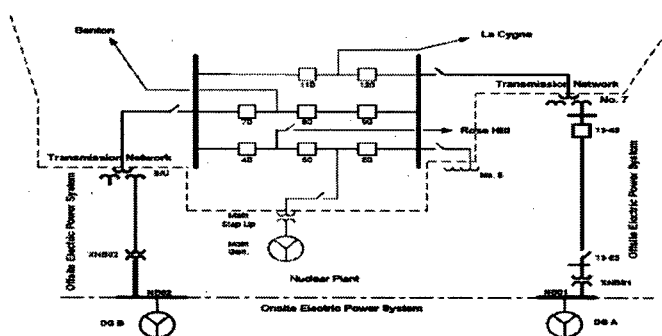
Offsite power is supplied to the WCGS switchyard from the transmission network. From the switchyard, two electrically and physically separate offsite circuits provide AC power through the ESF transformers, to the 4.16 kV ESF buses. See Figure 1 below. One offsite circuit feeds through ESF transformer XNB01 and supplies power normally to its associated 4.16-kV Class 1E bus [EIS Code: EK]. The other offsite circuit feeds through the startup transformer (S/U), through ESF transformer XNB02, and supplies power normally to its associated 4.16-kV Class 1E bus. In addition, each offsite circuit can be manually aligned to supply power to the opposite or both 4.16-kV Class 1E busses, if required. Each of these offsite circuits is designed to be available in sufficient time to ensure that specified acceptable fuel design limits and design conditions of the reactor coolant pressure boundary are not exceeded following a loss of all onsite power sources and the remaining offsite circuit.
